# Manhole Inspection Summary

Manhole # S43SS\_007MH

Insp Date: **2/27/07 9:39 AM**

**Location** Address: **2653 AISQUITH ST**

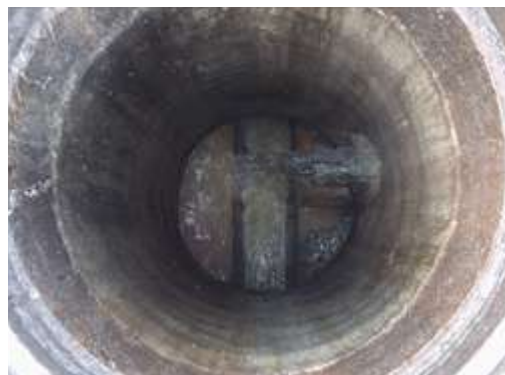
Top View

Frame leaks. Corbel infiltration.

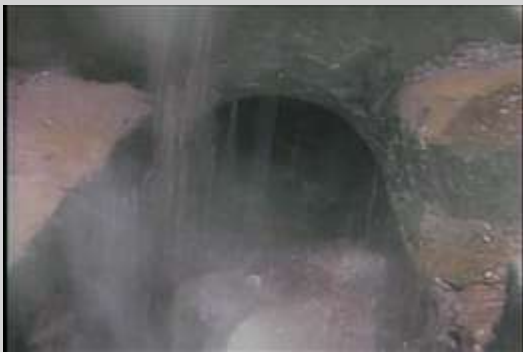
### 18 in. Circular Gravity Sewer Pipe Out @ 12 O'Clock

Pipe Material: **Clay** ☐ Pipe Lined

Invert Depth: **13.27** (ft.) Flow Characteristics: **Fast**

Infiltration: **None** Pipe Seal Cond: **Unknown**

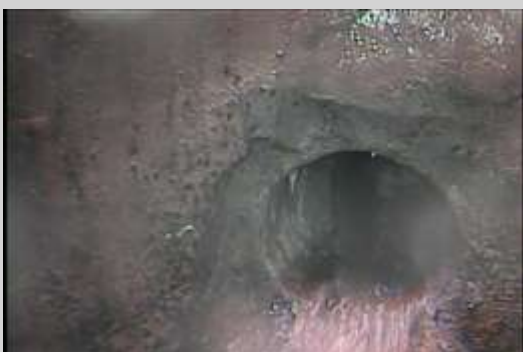
### 8 in. Circular Gravity Sewer Pipe In @ 3 O'Clock

Pipe Material: **Clay** ☐ Pipe Lined

Invert Depth: **6.07** (ft.) Flow Characteristics: **Slow**

Infiltration: **None** Pipe Seal Cond: **Unknown**

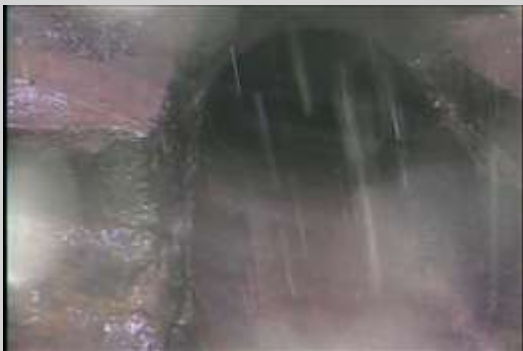
18 in. Circular Gravity Sewer  
Pipe In @ 6 O'Clock

Pipe Material: **Clay** ☐ Pipe Lined

Invert Depth: **13.00** (ft.) Flow Characteristics: **Fast**

Infiltration: **None** Pipe Seal Cond: **Unknown**
